Appendix A: Data Sheets and Field Forms

Vehicular Security Center at World Trade Center: Vessel Inventory Form

Site Name: Vehicular Security Center at World Trade Center

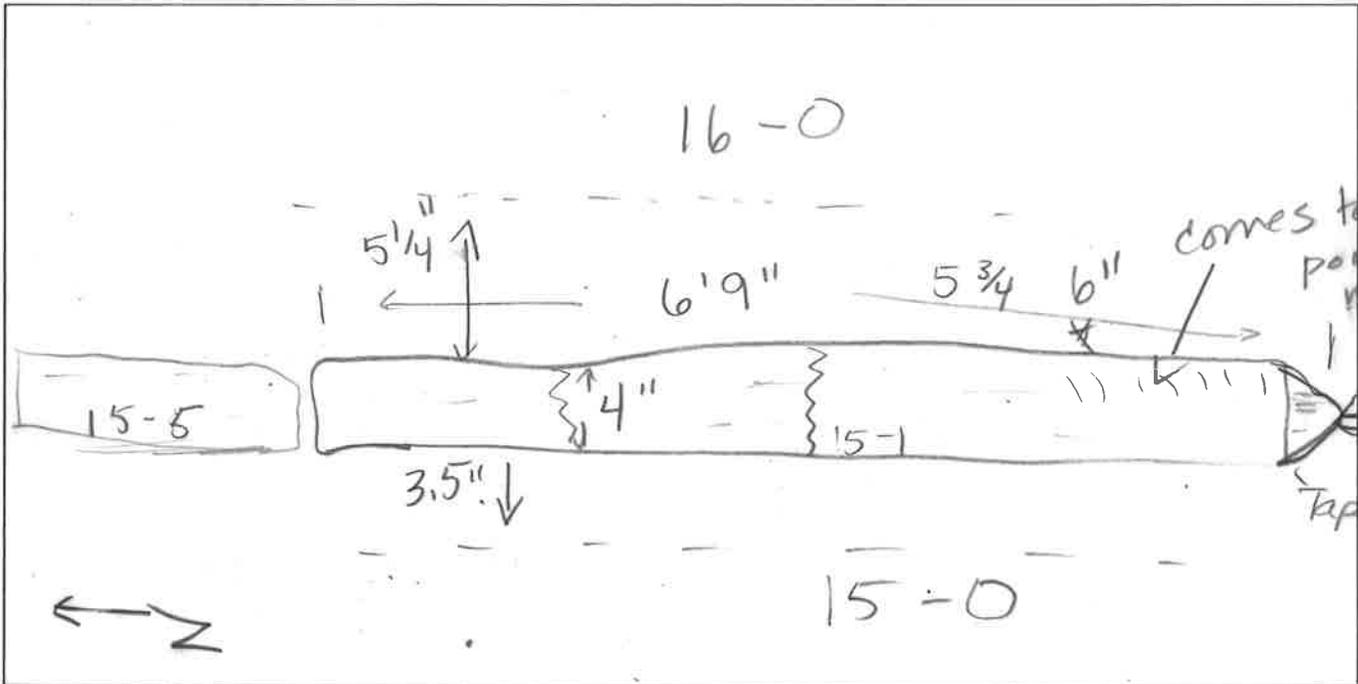
Notes tapers to point near keelson
15-1 Now Broken into 3 pieces

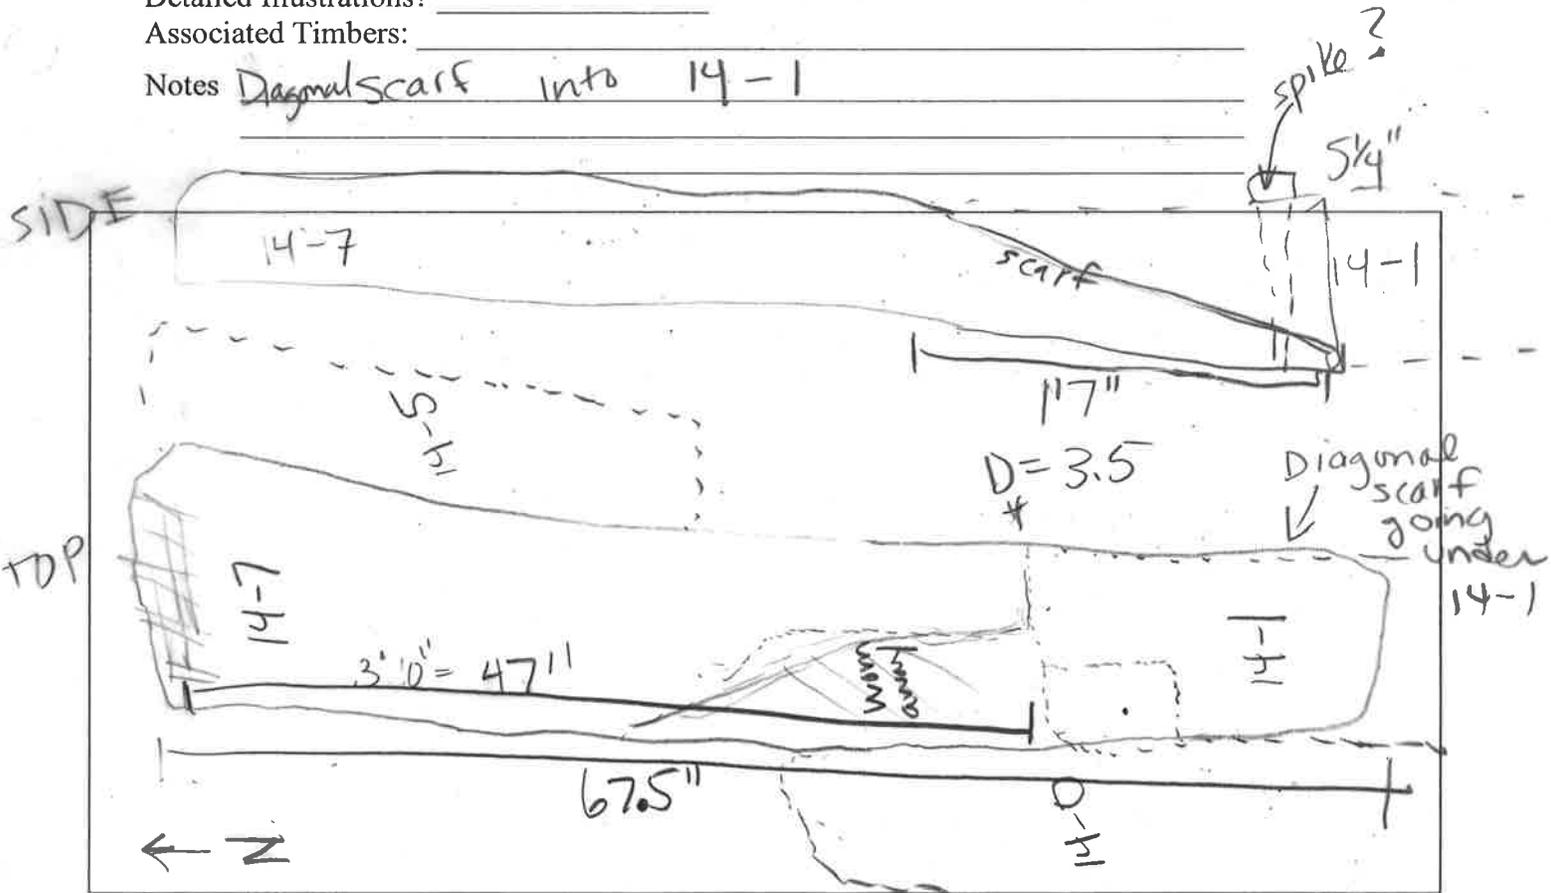
Notes Diagonal scarf into 14-1

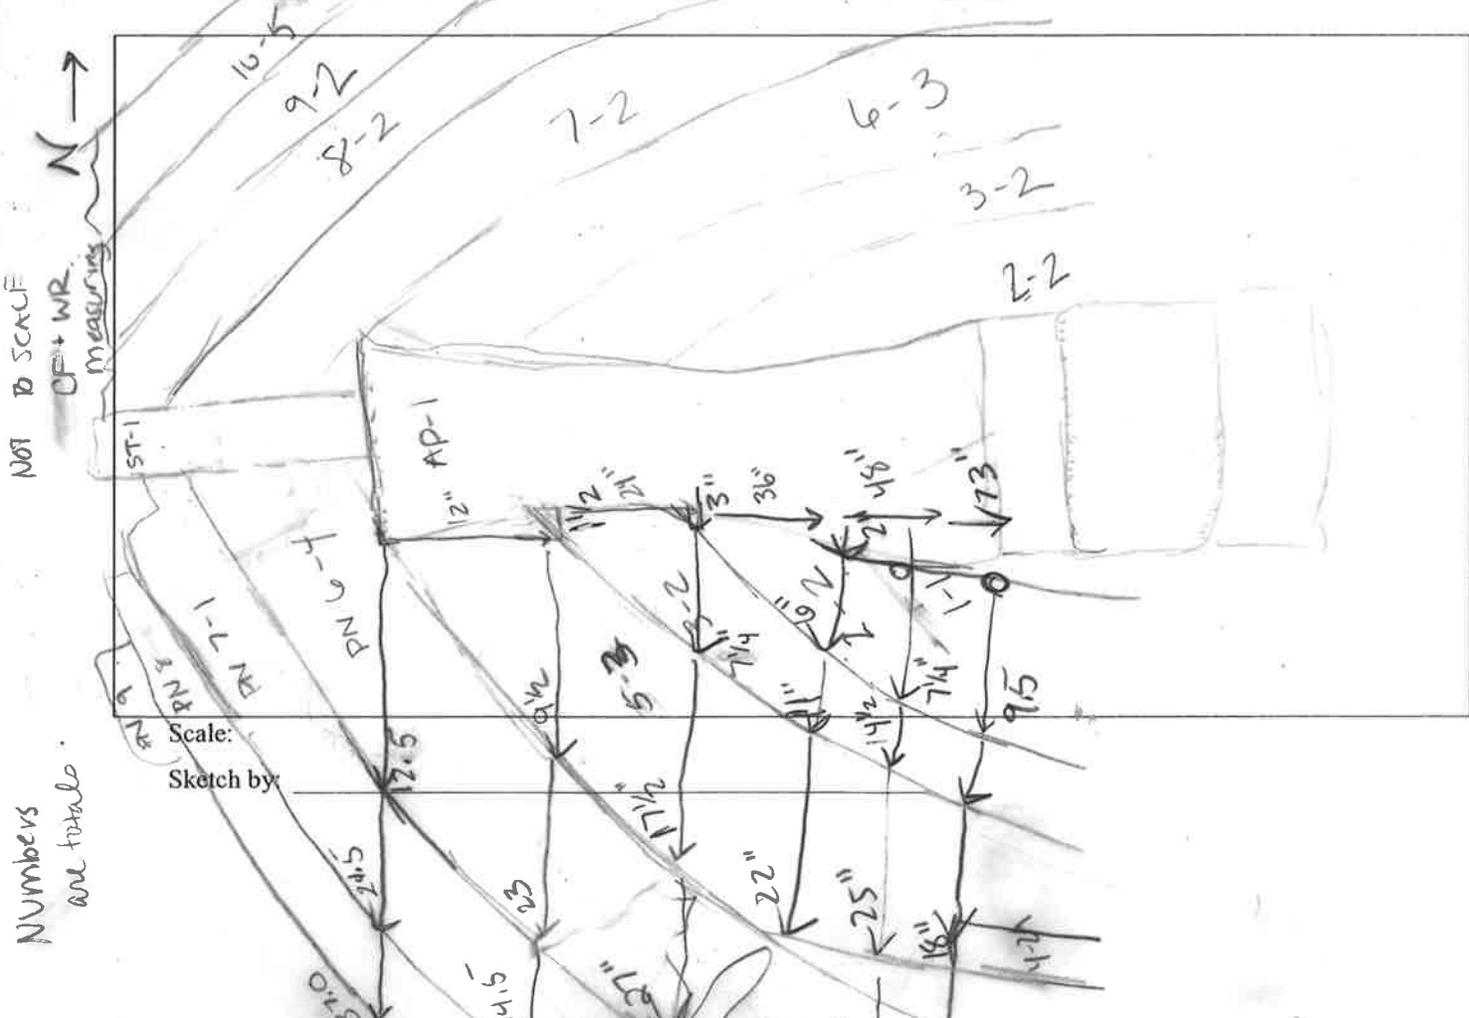
Notes station lines going out from apron. vertical + horizontal measurements kept in plane

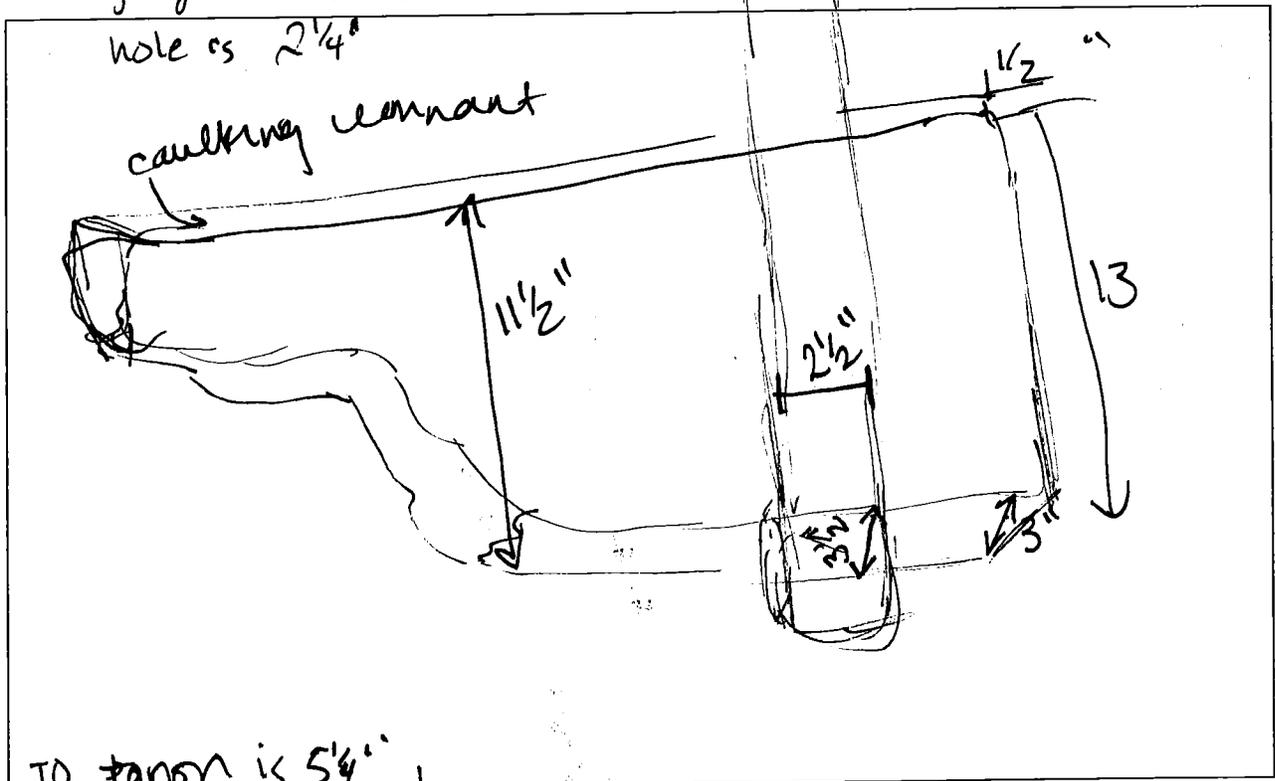
strap 2 1/2" thick. from tip to gudgeon
gudgeon 1 3/4" thick iron
hole is 2 1/4"

TO tenon is 5 1/4"

1 3/4" tenon

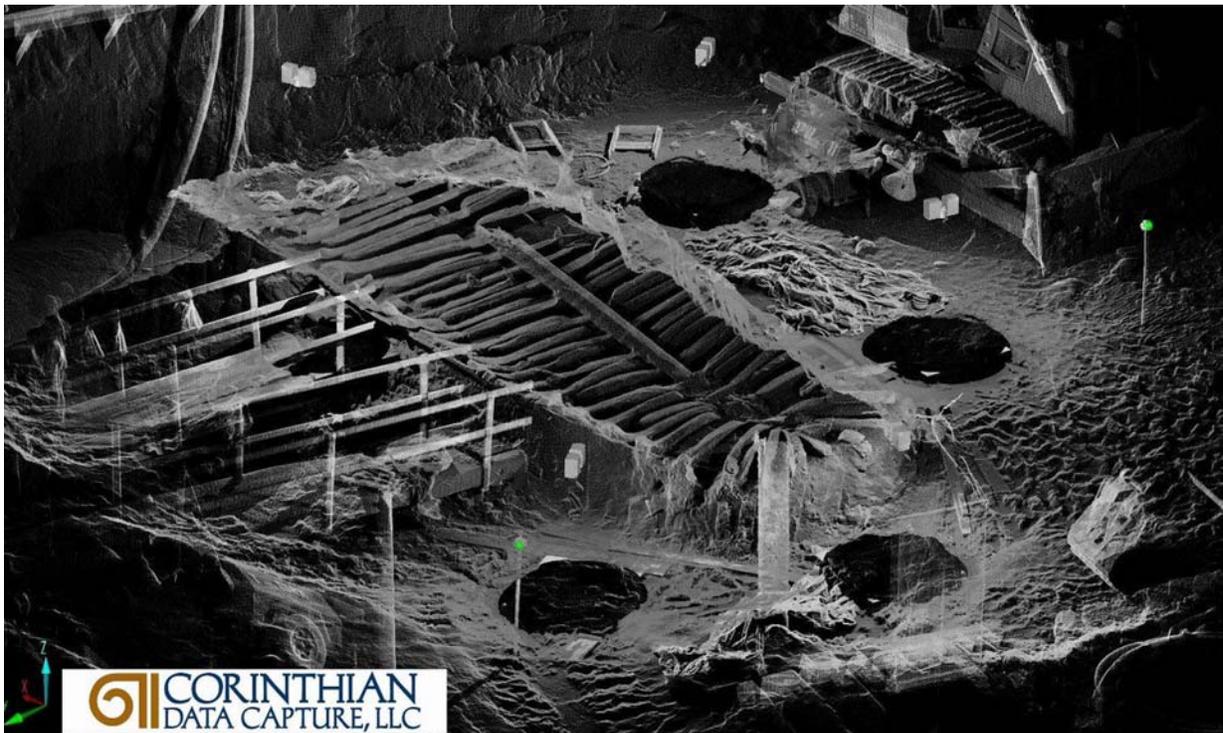
Figure 1 – Laser Scan of Ship Frame In-Situ at the World Trade Center Site. Provided by: Diane Dallal, Director of Archaeology, AKRF, INC., New York, NY 10016

On July 13, 2010 workers excavating the site of the underground Vehicular Security Center for the future World Trade Center hit a row of sturdy, upright wood timbers, regularly spaced, sticking out of the mud. The world was surprised when it was announced that a 32' section of the hull of a wooden ship was being recovered. Archaeologists Molly McDonald and A. Michael Pappalardo, both of AKRF, Inc., the firm hired to monitor construction during the construction process, were on site at the time of the discovery. As reported by the New York newspapers, "They began cleaning mud and silt away from the timbers by hand". Figure 1 shows a laser scan of the site when the assemblage was exposed.

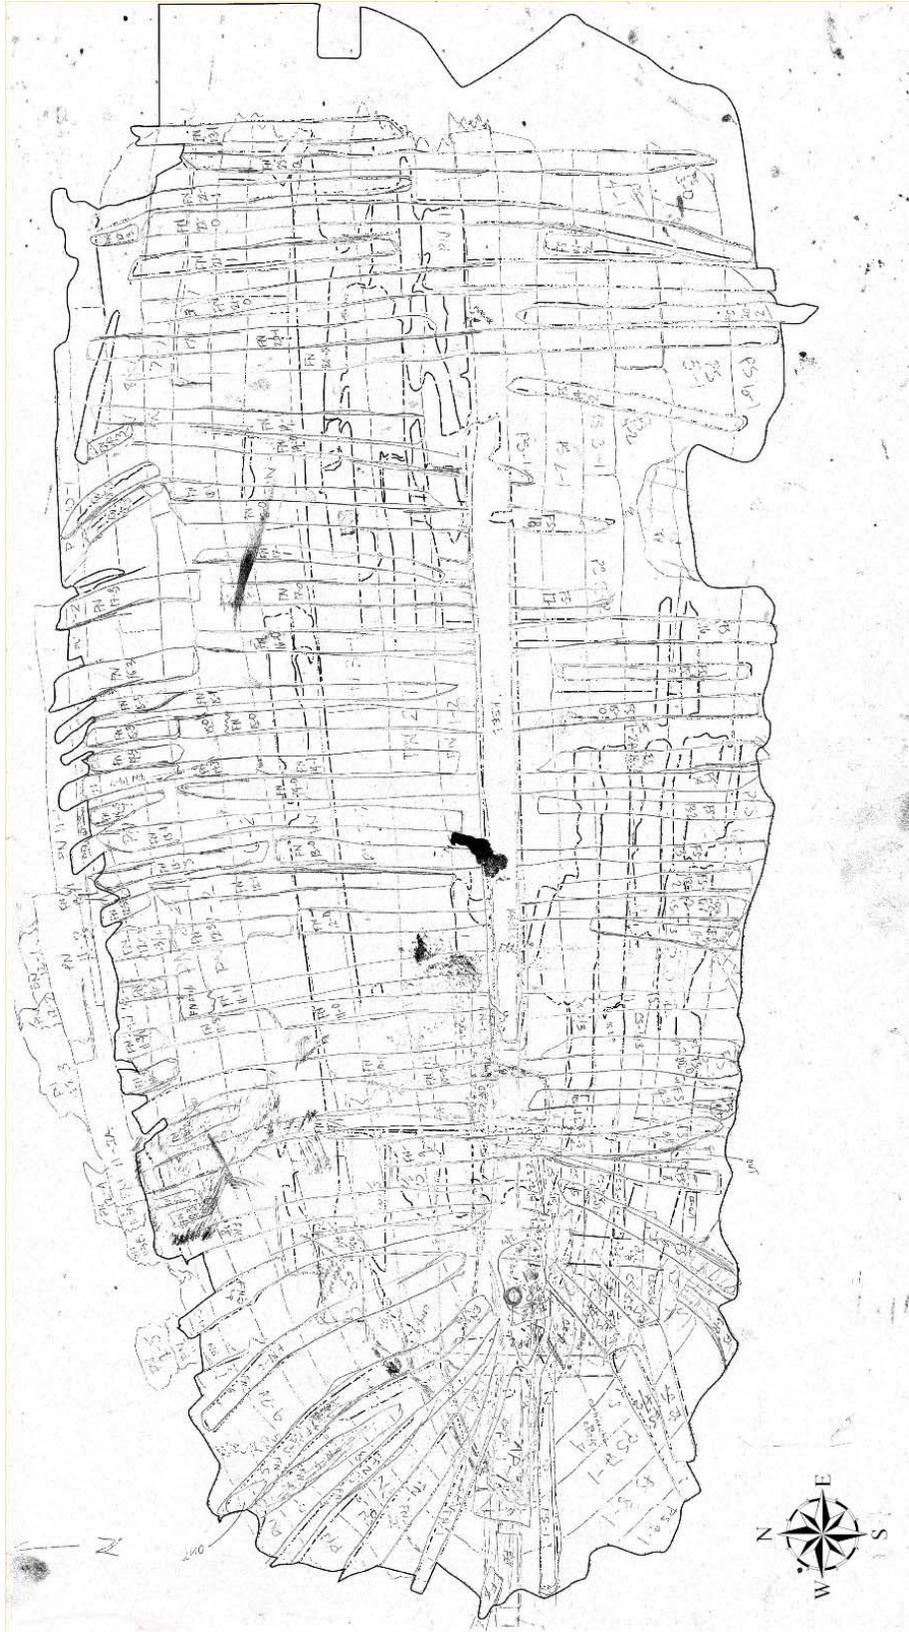
Figure 2 - World Trade Center Ship: Frame and Planking Composite of Field Sketches

Figure 2 shows a composite of the field sketches of the layers of timbers removed. Only five days were allowed for the removal of the vessel and any artifacts. Most of the small artifacts were recovered by water screening. As such, it was nearly impossible to point-provenience each artifact. A number of ordnance or ordnance related artifacts, such as a cannon ball, musket balls, small lead shot, gun flints, and more were recovered. Diane Dallal of ARKF contacted the author, Dan Sivilich, President and Founder of the Battlefield Restoration and Archaeological Volunteer Organization (BRAVO) for assistance in identifying the artifacts in an effort to more precisely date the ship. The author has over 20 years experience working with Revolutionary War Era military artifacts specializing in musket balls and other lead shot (Sivilich 1996, Sivilich 2004).

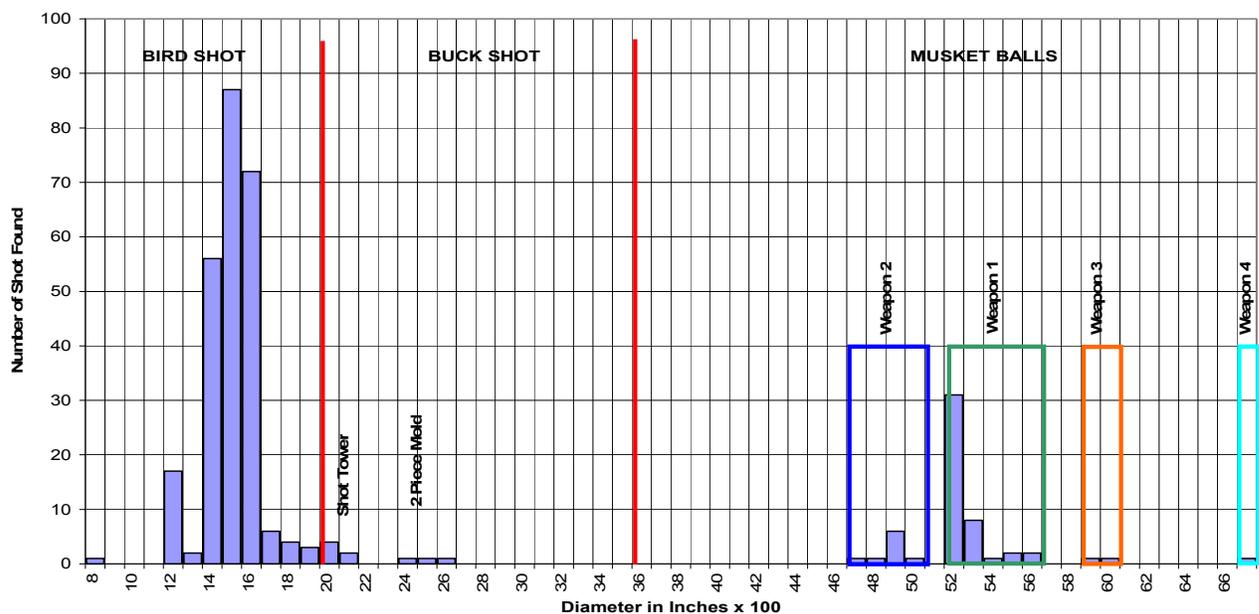
Figure 3 - Lead Shot Sizes Found on the Ship Excavated at the World Trade Center Site

As shown in Figure 3 and Table 1-3 (see Attachment B), of the 313 pieces of lead shot recovered, 251 were birdshot. Birdshot is defined as having diameters from 0.08" to 0.19" inclusive. The majority of the birdshot (215 pieces) had diameters of 0.14" - 0.16". No birdshot has been recovered by BRAVO at Monmouth Battlefield or any other Revolutionary War site that the author has been involved with. Typical military buckshot is 0.30" - 0.36" in diameter. In 1776, General George Washington issued a general order that the men shall load their muskets with one musket ball and four to eight buckshot for their first volley. However it was a more common practice to use one ball and three buckshot (Peterson 1968). Since most of the Americans cast their own shot, the diameter became more of a function of the sprue hole in which the lead was poured (Refer to Figure 1 of the attached paper on manufacturing lead shot). Several musket balls have been excavated at Monmouth Battlefield having the impression of 3 buckshot impressed into the lead musket ball (Sivilich 2004:5).

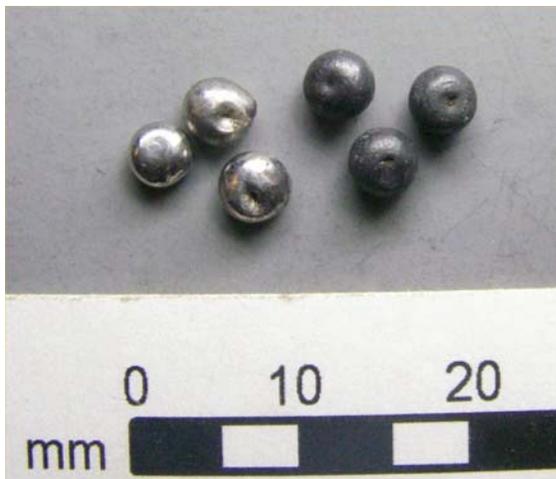
Figure 4 - Experimental shot to the left and WTC shot to the right

Most of the birdshot was slightly out-of-round, apple-shaped and had a distinctive dimple. An experiment was conducted to determine how the birdshot was manufactured (Attachment C). The results show that it was produced using the short drop method. As shown in Figure 4 below, the experimental shot had the same dimple and was roughly the same size as the WTC shot. Occasionally a droplet was not hot enough to create a sphere but would form a tear-shaped droplet instead. This was also reproduced in the experiment as shown in Figure 4. This production method was used before shot towers were invented. The first shot tower built in the US was constructed in 1808 (Spivak 1990) in Philadelphia. Birdshot and dust shot have been linked to slave ships, such as the Whydah that went down off Cape Cod in 1717 (Kinkor 2010). Due to its light weight, the knock-down power of birdshot is minimal and not deadly. Therefore it was kept on board to quell potential riots. With a low powder charge, it could cause sufficient pain to stop slaves, but without causing irreparable damage to the "merchandise". . Alternatively it could have also been available as an anti-boarding weapon to be used against pirates or other undesirables. Based on the marine biology analysis of the outer planking (which will be covered in the ARKF report), this vessel did spend time in the Caribbean which was known for being infested with pirates. However, it was most likely used for hunting water fowl for food which is what it was specifically designed for.

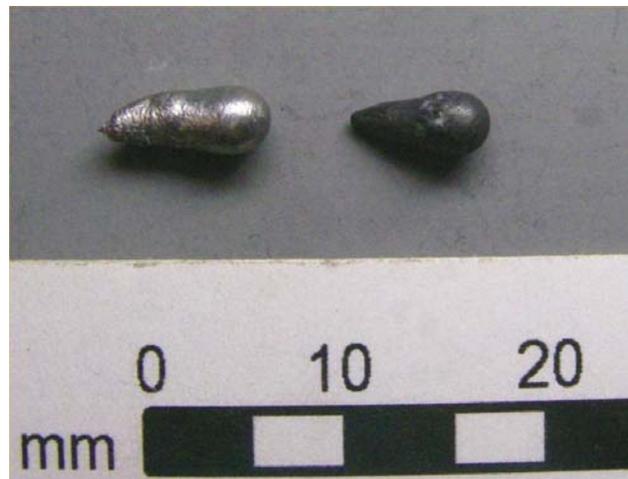
Figure 5 - Experimental shot to the left and WTC shot to the right

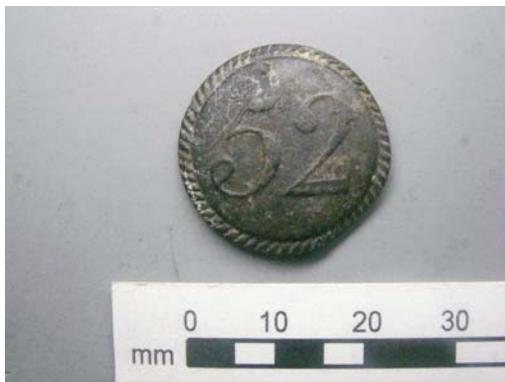
Only one button was found. It is a British 52nd Regiment of Foot button in excellent condition. It is 23.5 mm in diameter and is made of pewter. It is a standard pewter private's button, not an officer's button (Troiani,- personal communication, November 3, 2010). The 52nd Regiment, also known as the Oxfordshire Regiment, was very active during the Revolutionary War from 1775 to 1778. They participated in Lexington and Concord; Bunker Hill; Siege of Boston; Long Island; Pell's Point, White Plains; occupation of Newport, Rhode Island; Fort Mifflin; Princeton; Brandywine; Fort Mifflin; occupation of Philadelphia; Monmouth Courthouse and the retreat to Sandy Hook and New York (Troiani 2001:58). They were last stationed in New York until 1778. Possibly the WTC ship was used to ferry troops from the dock to the British warships and troop transports that were docked in Raritan Bay. However this button does provide the *terminus post quem* date of 1775 for the sinking of the vessel.

Figure 6 - British 52nd Regiment of Foot button

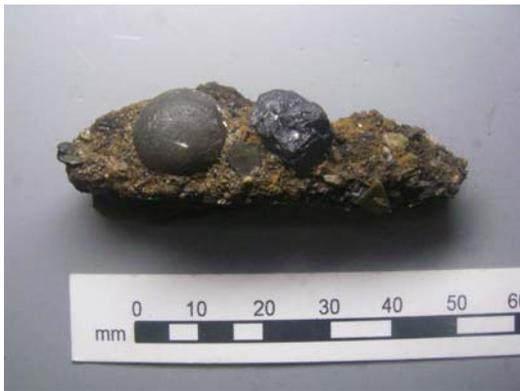
A small piece of anthracite coal, known as pea coal based on its size, was found embedded in a concretion next to a musket ball. This context strongly suggests that the coal was associated with the ship. A small coal stove for cooking and heating was far more efficient than a wood-burning stove.

Figure 7 - musket ball (left) and pea coal (right) in concretion

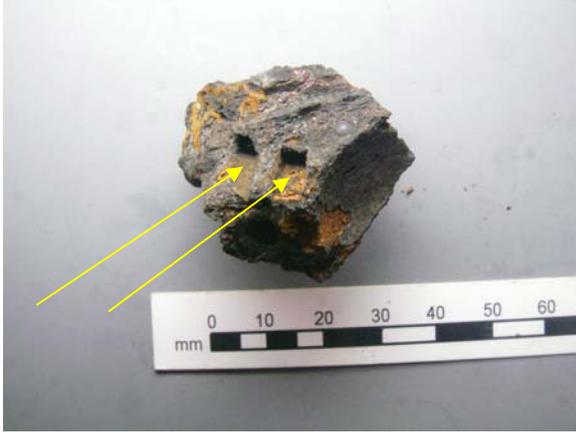
Figure 8 - WF10S-017: Concretion with 2 square nail holes

Two of the concretions were of particular interest because they had rectangular holes piercing them. The holes were impressions of where square nails once resided and have since rusted away. This appears to be the source of much of the rust found on the concretions. A thorough examination of the holes might determine if they were made by wrought nails or machine cut nails.

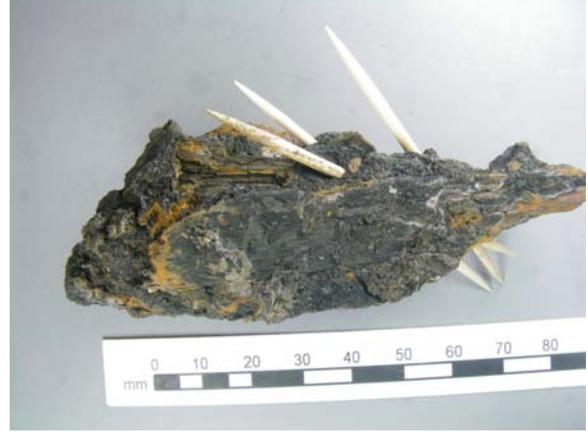
Figure 9 - WF10S-022: Concretion with toothpicks showing locations and directions of 3 square nail holes

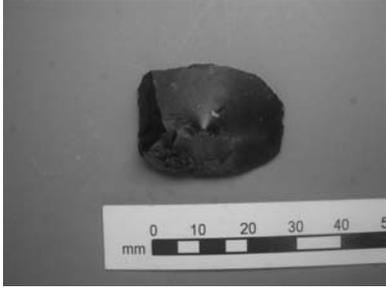
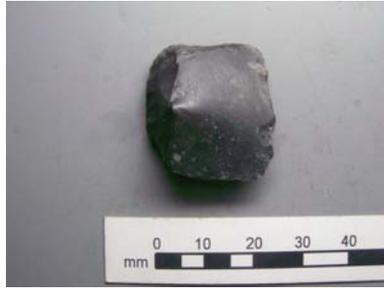
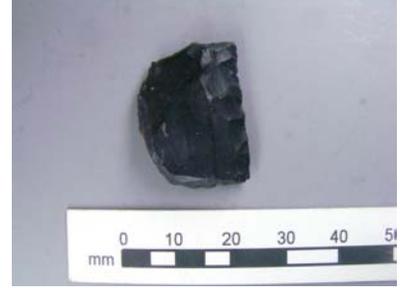
Three gun spalls, wedge-shaped gun flints with curved backs (Hume 1991:219-221), were recovered from three different locations on the ship and are shown in Figures 10 - 12.. All three were made from black flint from the chalk regions, in and around Dover, England. However, this material was in common use in this country for centuries. "Dover" flints have been found by the author on numerous domestic sites throughout New Jersey and in several other states. The spall shape suggests that these were for domestic use. British military flints are typically square with a trapezoidal cross section.

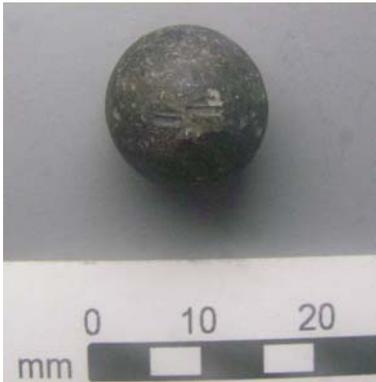
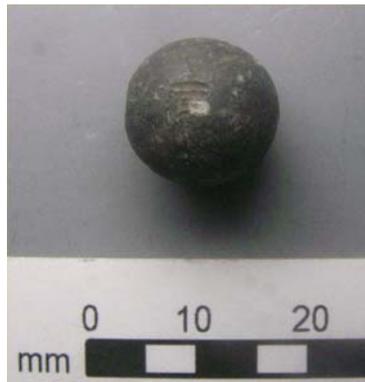
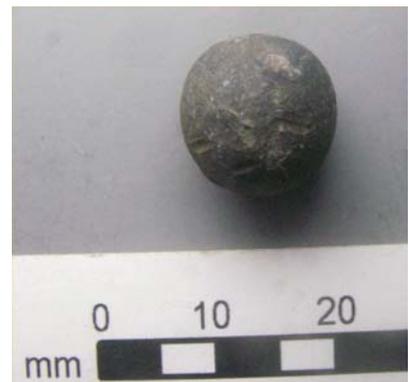
3 musket balls were chewed by rats (Figures 16-18) as identified by zoo-archaeologist Henry Miller, Ph.D., Director of Research and Maryland Heritage Scholar at Historic St. Mary's City, St. Mary's City, Maryland (personal communication email, November 12, 2010). The parallel line gouges are too small to be human. Experimental testing by Dr. Miller and the author actually chewing on lead musket balls show totally different patterns for humans (Sivilich 2009:91-93). The small parallel lines match rat incisors as compared to skeletal bite marks made into clay by Dr. Miller. This obviously indicates the presence of rats on board before the ship sank and that the musket balls were probably in a dry environment.

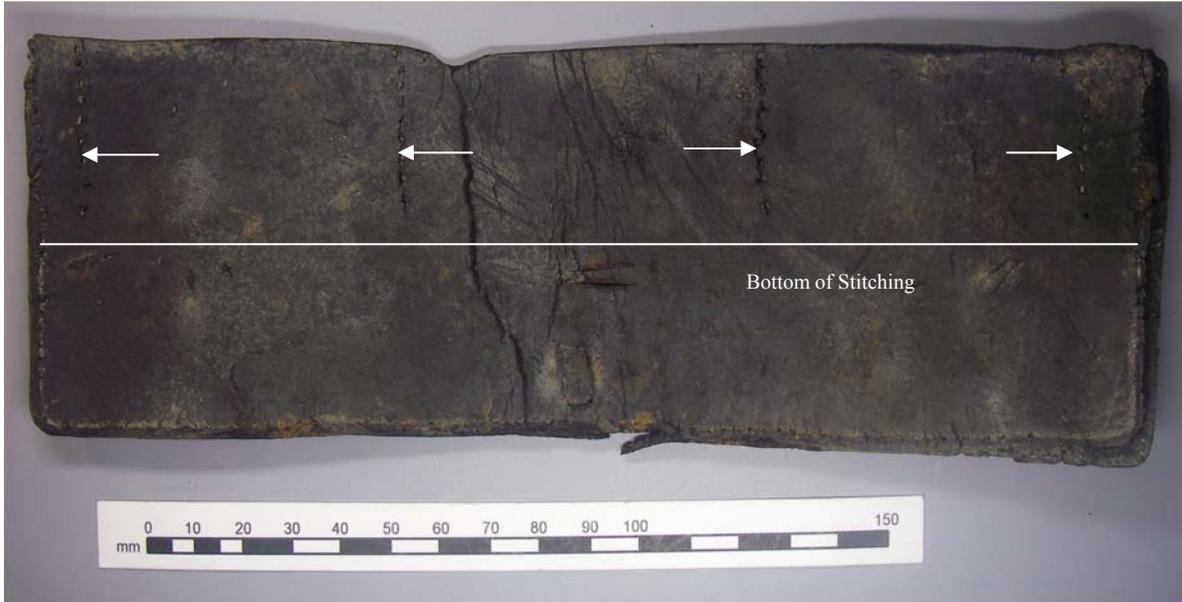
Artifact # USP-002 is a black leather pouch or wallet that has 3 stitched compartments, but the stitching is not completed from top to bottom. Its specific use is not known by the author.

Figure 19 - Artifact # USP-002: Pouch or Wallet?

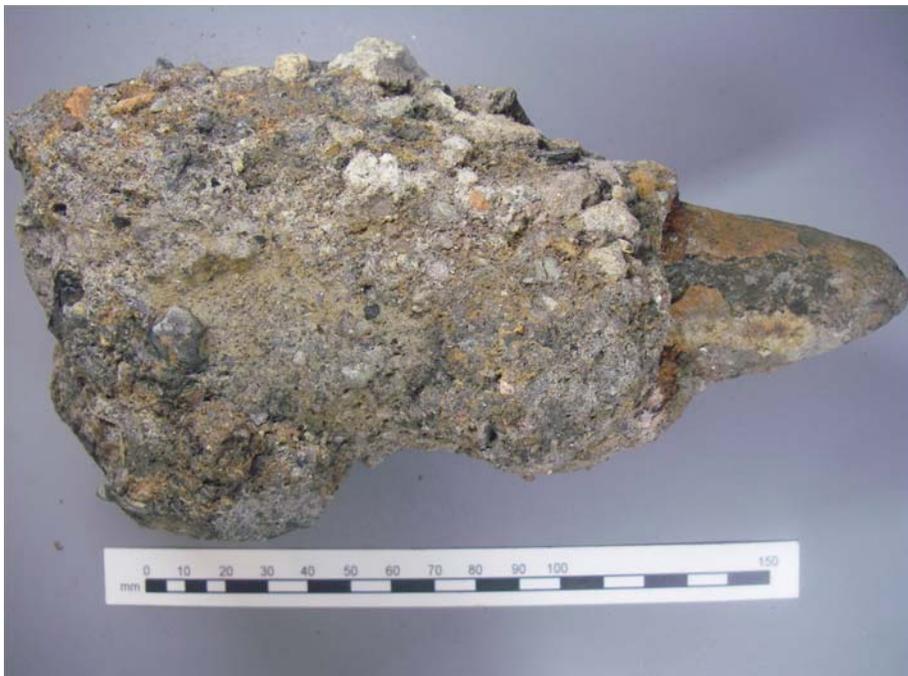
Artifact # MISC-001 appears to be the tip of a wooden spike that has an iron sheeting overlay. The author's initial reaction was that this was a possible defensive chevaux-de-frise. However, given its location and small diameter, it is most likely the remnant of an iron-tipped piling.

Figure 20 - Ironclad spike, probably a piling

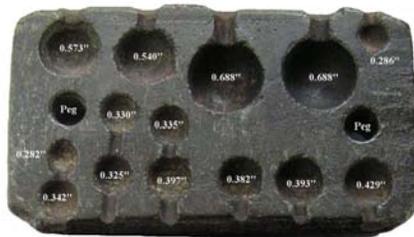
Figure 1 - 1776 mold (Courtesy of Monmouth County Historical Association, Freehold, NJ)

In July of 2010, a 32' fragment of a wooden sailing vessel was found in the subsoils of The World Trade Center site in Lower Manhattan. 346 artifacts were found that had the potential of being 18th-century military. I was retained to identify and possibly determine the age of them. 251 of the artifacts were identified as bird shot - lead shot with diameters ranging from 0.08" to 0.20" inclusively. Only 8 buck shot were found. Buck shot, 0.21" - 0.36" diameter lead shot, is typically made from a 2 part mold. The casting usually leaves an imprint of the mold seam and a clip mark of where the sprue was attached to the ball.

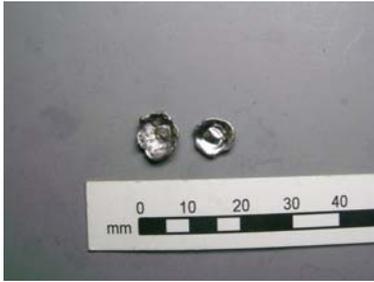
Figure 4 - drop height of 5'

In an attempt to identify the type and rough time period of manufacture, I designed a preliminary experiment. Using available materials, I took some 40/60 tin/lead solder in approximately 1/8" diameter wire form. Using a propane torch while standing, I melted several droplets off into a container of cold tap water which was on the floor. The drop height was approximately 5'. The results are shown in Figure 4. The lead did not have sufficient time to solidify. I therefore increased the height to 7' by standing on a chair. These results are shown in Figure 5. Nearly the opposite effect than expected was achieved. The lead splatter was worse. Clearly significantly less height would be needed.

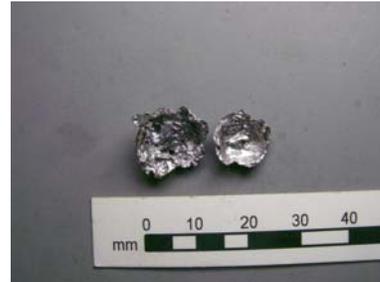
Figure 5 - drop height of 7'

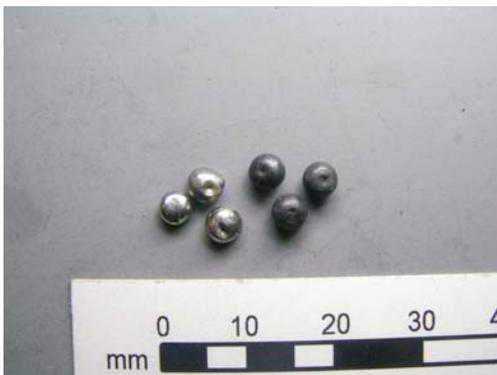
Figure 6 - experimental shot to the left, actual shot (FS9-3) to the right

I found that as I got closer to the water, the more spherical/apple-shaped the drops became and began developing the desired concave dimple. I reduced the height to less than 1/4" from the water. The resulting shot produced are shown in Figure 6 next to actual shot recovered from the ship remains.

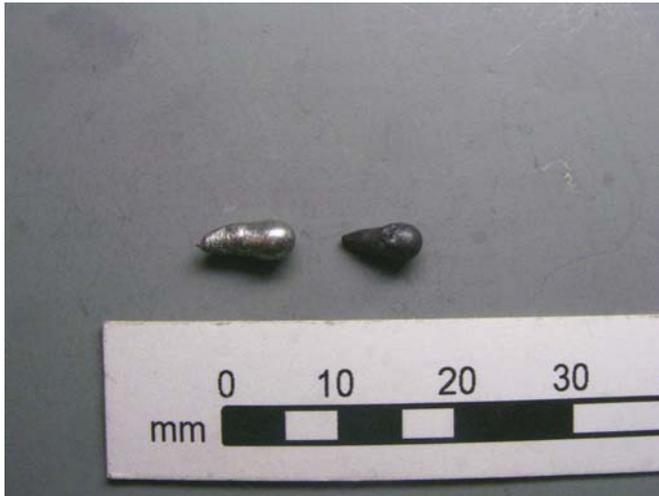
Figure 7 - Experimental shot on left and actual shot on right

Further evidence that this method was used was when the lead alloy was being melted, a tear drop formed if the heat was not applied uniformly. Figure 7 shows a tear drop that was produced during the experiment (left) and one found on the ship (right).

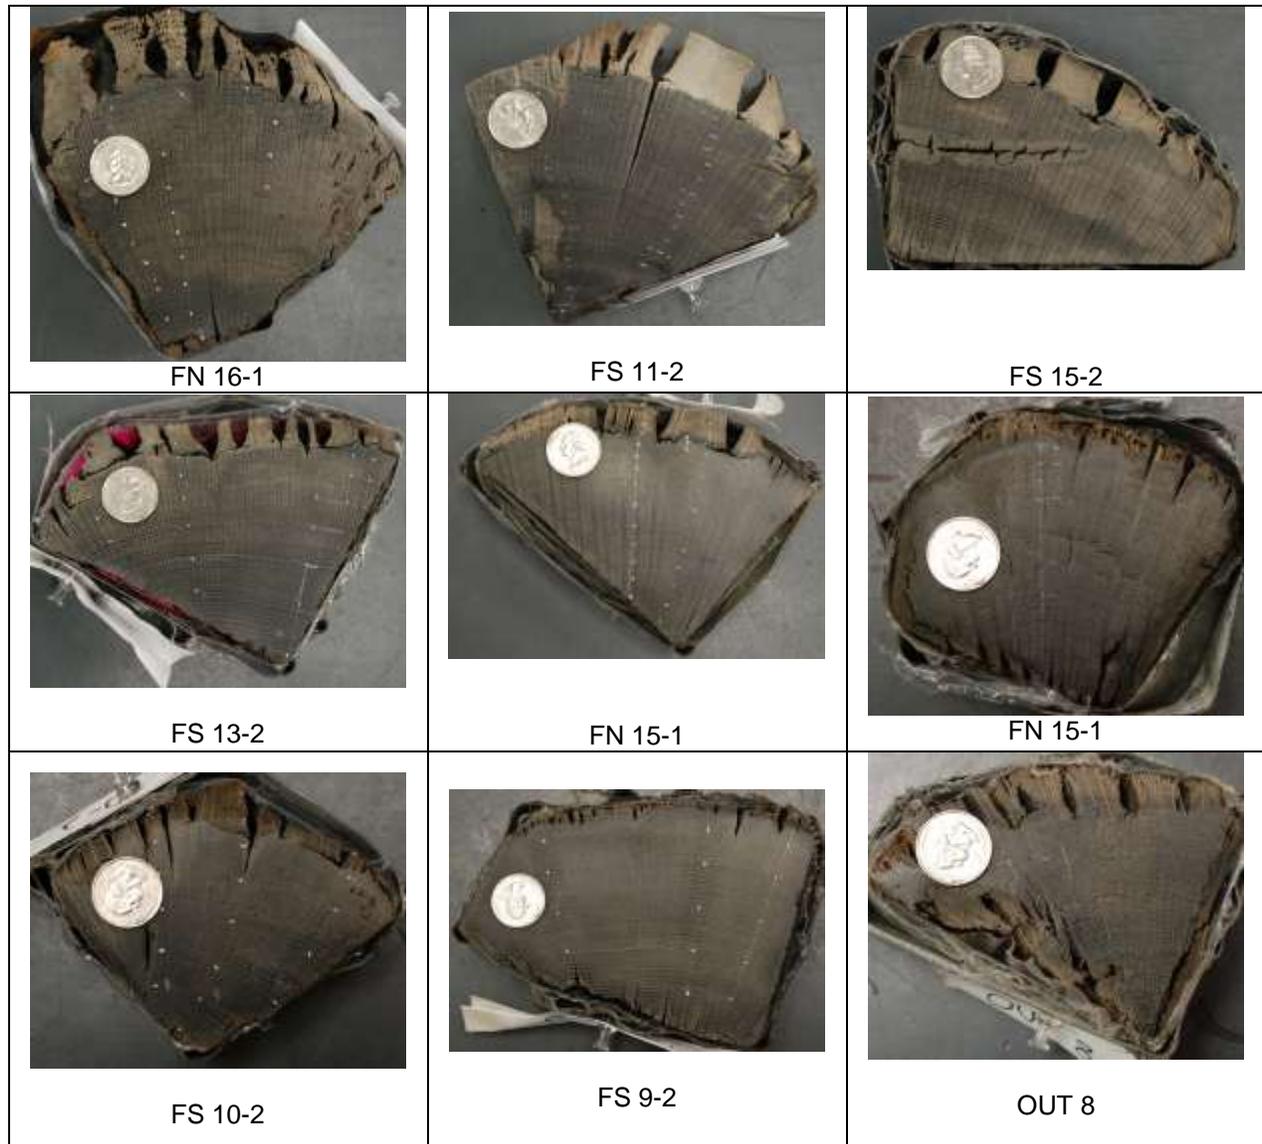
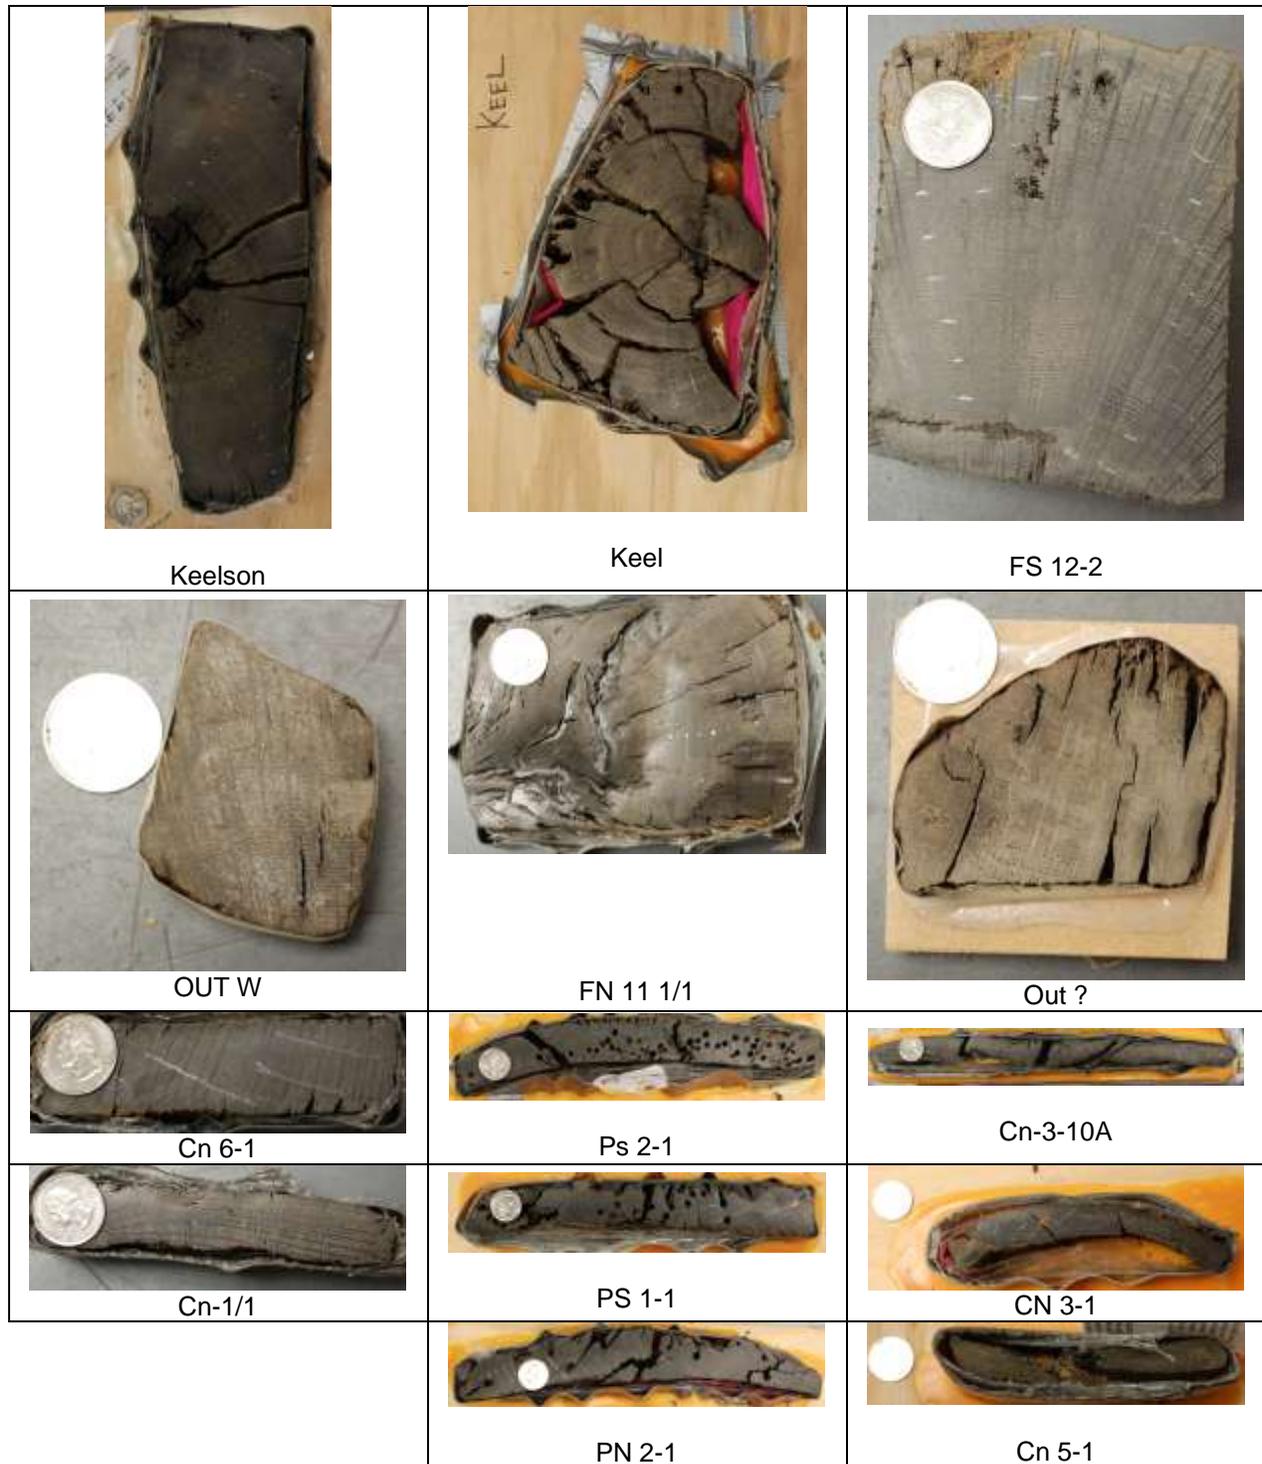
Figure 1. Photographs of the 23 WTC vessel timber samples analyzed by tree-ring analysis. Refer to **Table 1** for the wood species and dates of the samples.

Figure 1 (continued). Photographs of the 23 WTC vessel timber samples analyzed by tree-ring analysis. Refer to **Table 1** for the wood species and dates of the samples.
